Materials Sciences Corporation

MICROMECHANICAL EVALUATION OF
CERAMIC MATRIX COMPOSITES

Technical Final Report
MSC TFR 2201/1506
February, 1991

Contract No. F49620-88-C-0069

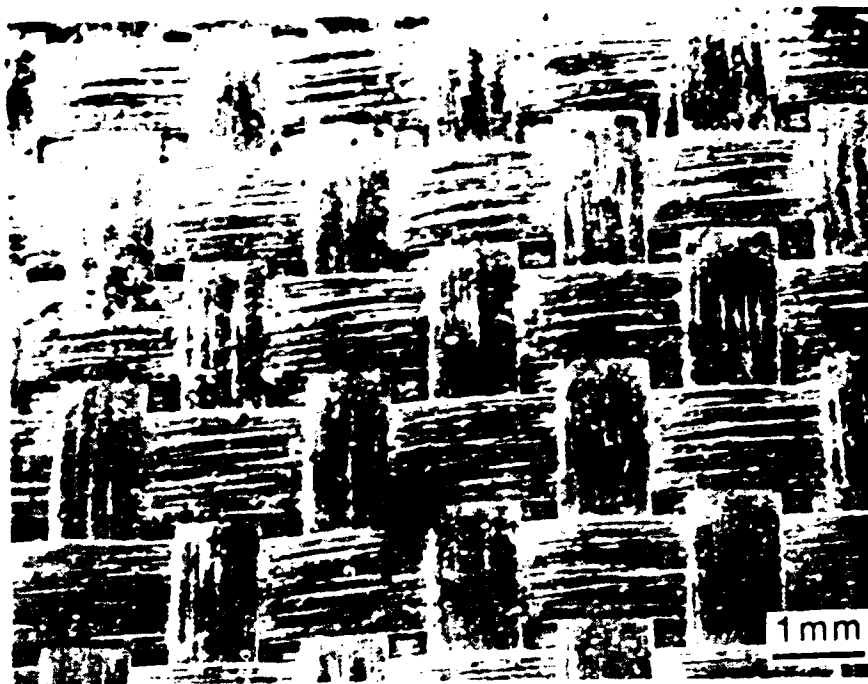
Figure 13. As-Received Carbon SiC Cross-Weave Composite

The external appearance of the as-supplied composite is shown in Figure 13. The composite is made up from several layers of carbon fiber bundle cross-weaves, inter-penetrated with SiC particles by a CVD process, coated with a layer of SiC, and the whole sintered into a rigid mass. The material was furnished in the specimen configuration shown in Figure 14 with the carbon plies oriented 0°/90°. The distribution of SiC was found to be highly inhomogeneous with a greater thickness existing between plies than between fibers in a bundle, which was reasonably close packed; the external layer of SiC was the thickest. The typical appearance of the intra-bundle regions, viewed by SEM, is shown in Figure 15. In this particular region, the fibers are not precisely close packed, but contacts between fibers numbering six were commonplace. In the region shown, there are three, four or five contacts per fiber. Figure 16 shows the Si map obtained by EDS technique corresponding to the region shown in Figure 15 and this confirms the chemistry of the SiC matrix. Note the highly defective nature of the matrix in which voids were commonplace both at fiber/matrix interfaces and within the matrix. Often these voids were found to be elongated in the fiber direction. The diameters of the fibers typically measured 7-8 μm .

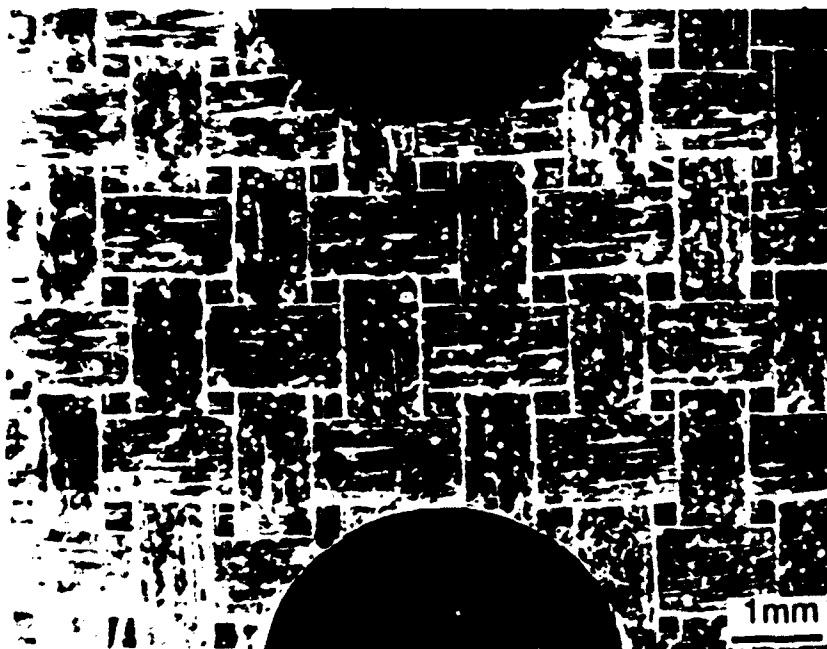
Figure 25. The Appearance of the Notched Gage Section on a Specimen for Studying Tensile Failure Processes, Before Loading

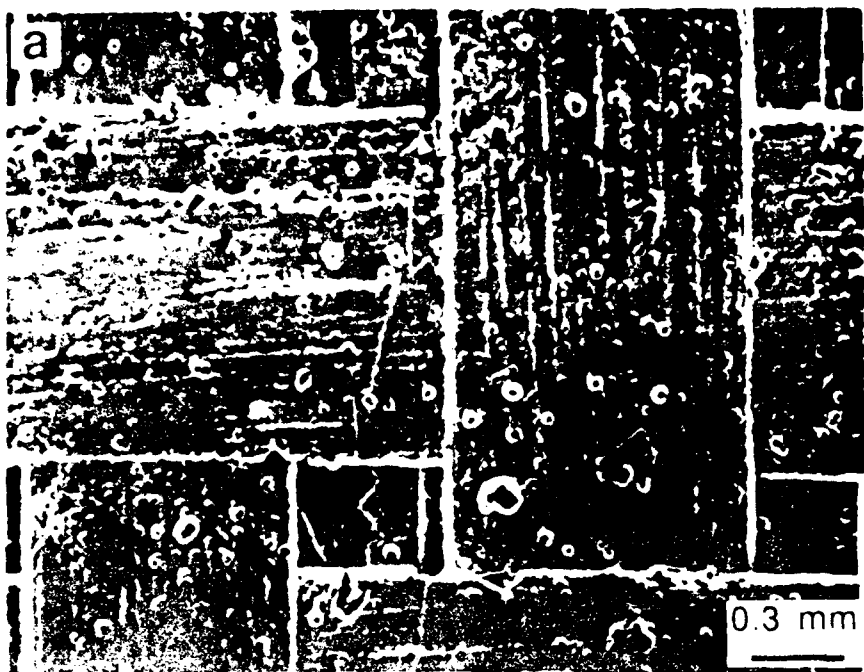
Figure 26. Cracking of c/sic composite after exposure to tensile load of 2681 N.
(a) Normal View; (b) Side View

lbs.) (just above the knee of the tensile load-deflection curve, see Figure 24). The resulting damages were observed in the SEM and are shown in Figure 26. Notice that surface cracks are visible (Figure 26) and a single surface crack stretches right to the specimen edge, stimulating local fracture of fibers (Figure 26). The specimen was then reloaded, first to 4022 N (900 lbs.) and again to 4469 N (1000) lbs. The same areas were examined by SEM after each reloading. Figure 27, showing SEM micrographs, indicates little subsequent change in surface cracking and spalling even after loading to 4469 N (1000 lbs). The specimen was finally fractured at 6256 N. Figure 28 illustrates the appearance of the fractured specimen at both the top and side of the gage section. In comparison with the surface cracks shown in Figure 26 and 27, it is clearly seen that the final failure path lies exactly along the surface cracks observed early in the deformation process. Figure 28 also demonstrates the possible internal damage modes: fiber fracture, delamination and fiber pullout. It should be noted that the damage appeared more localized than normally observed for long specimens, reflecting the "notched" gage section of the short specimen used.

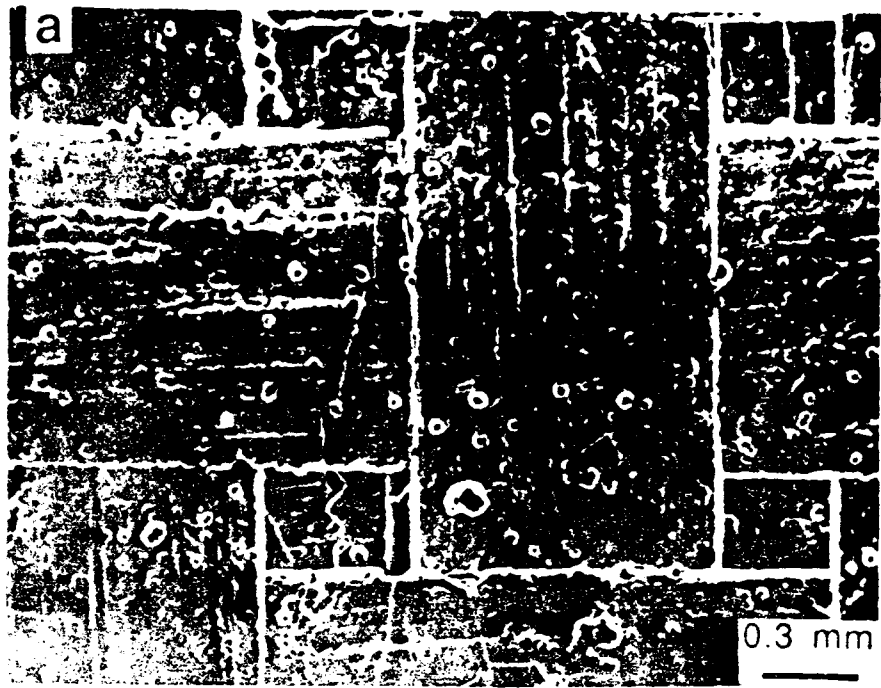
Figure 27. The Same Area as That Shown in Figure 14 After Loading in Tension to 4469 N (1000 lbs)

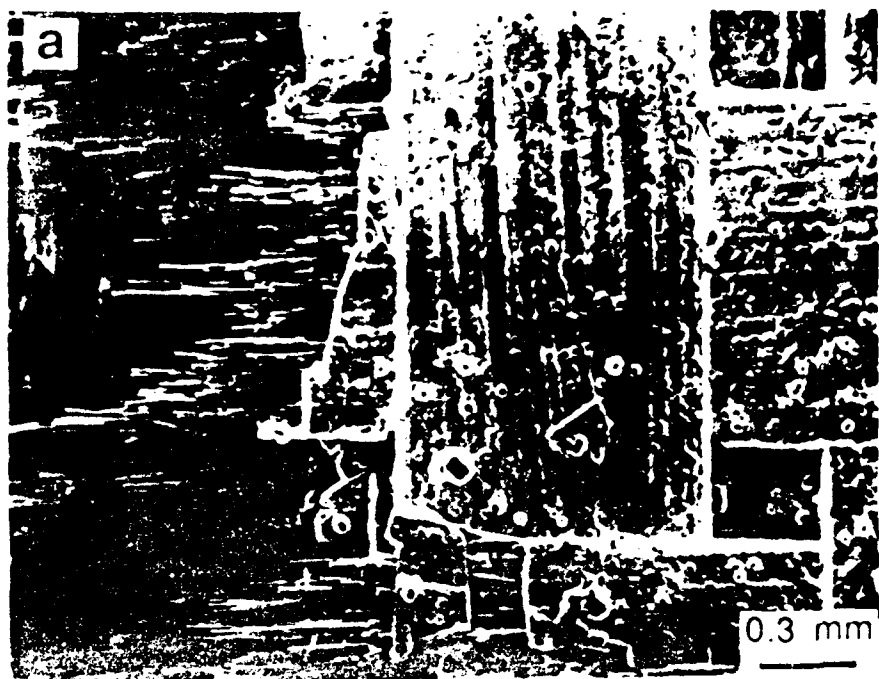
Figure 28. The Appearance of the Specimen After Fracture at 6256 N (1400 lbs); the Same Area as in Figures 14 and 15 is Shown

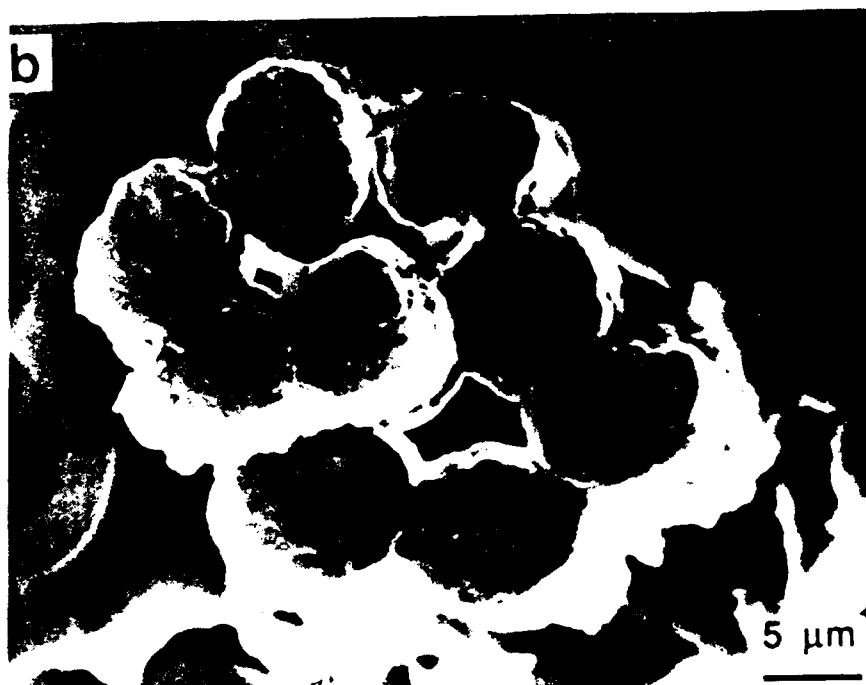
Figure 31. Characteristic Features of Fiber Bundle Fracture, Viewed Normal to the Fracture Surface

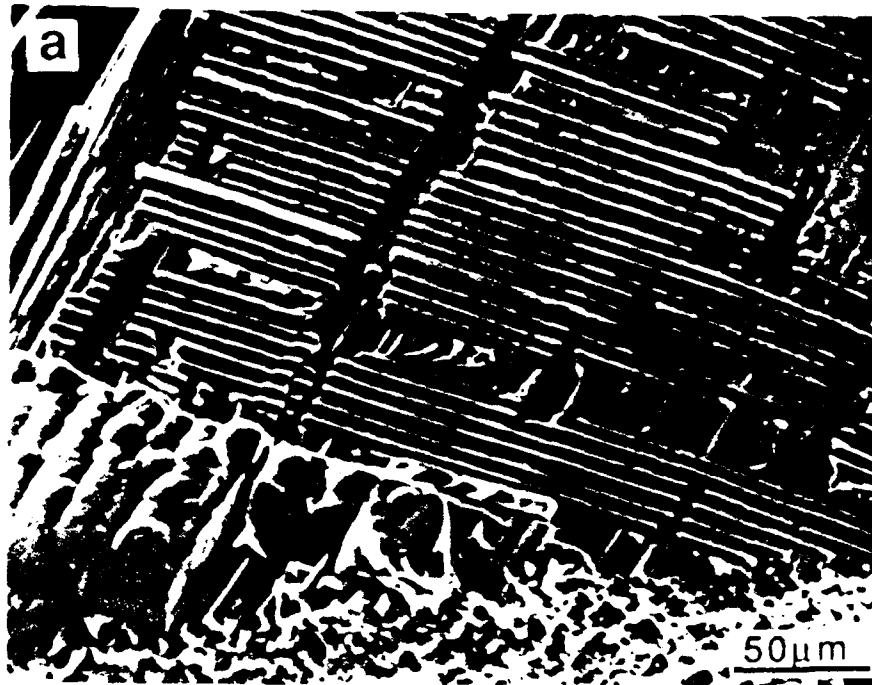
Figure 32. SEM micrographs of fracture surface, showing fiber debonding and pull-out (a, b) and showing an example of a matrix crack cutting fibers (b)
